**Geotechnical Report
Level One Inspection and Testing**

**Lavender Estate Stage 1
Beaconsfield VIC**

PROJECT No 8663

21 December 2015.

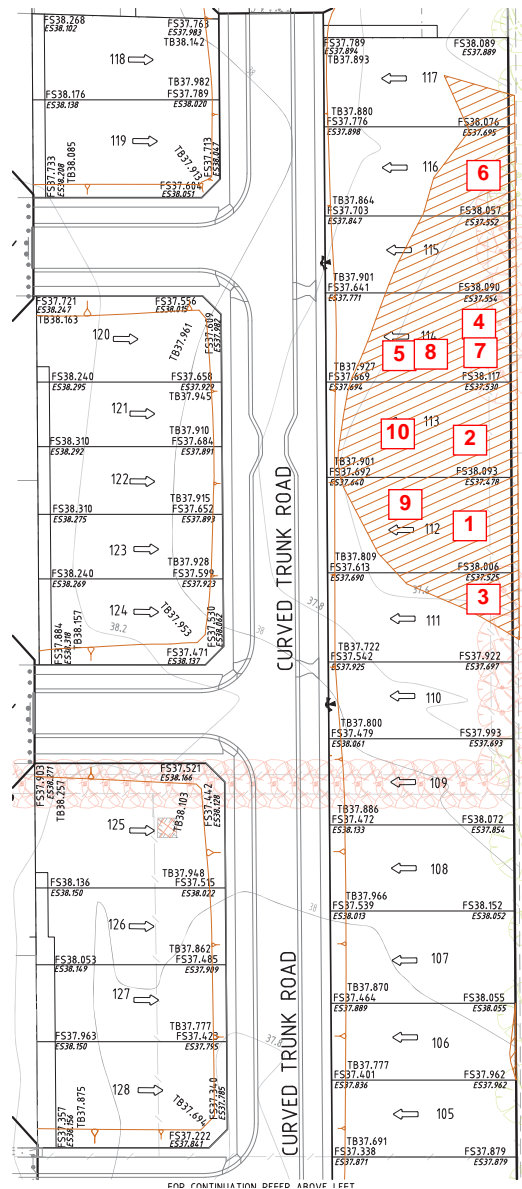
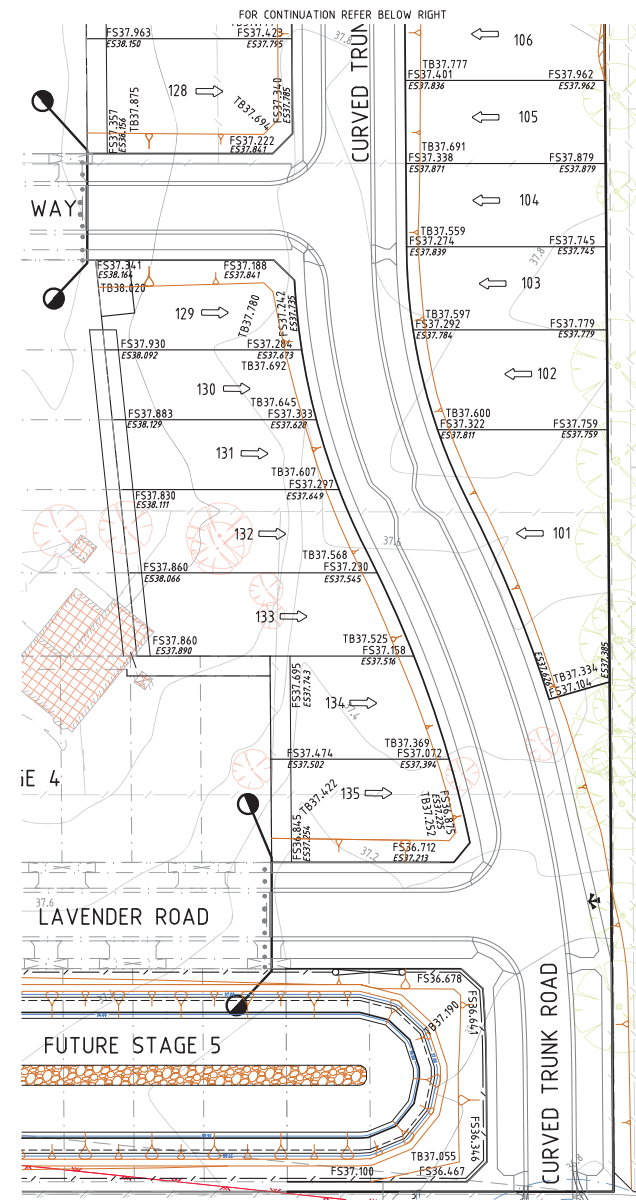
Test Location Plan

The area on which fill was placed is shown on site plan (Appendix 1) based on drawings prepared by Dalton consulting Engineers and provided by *Streetworks Pty Ltd*.

It was observed that finished levels were in accordance with levels marked on site by survey. These levels are shown on site plans attached in Appendix 1.
