**Geotechnical Report  
Level One Inspection and Testing**

**Lavender Stage 3  
Dam Back Fill  
Officer**

PROJECT No 8735

21 April 2016.

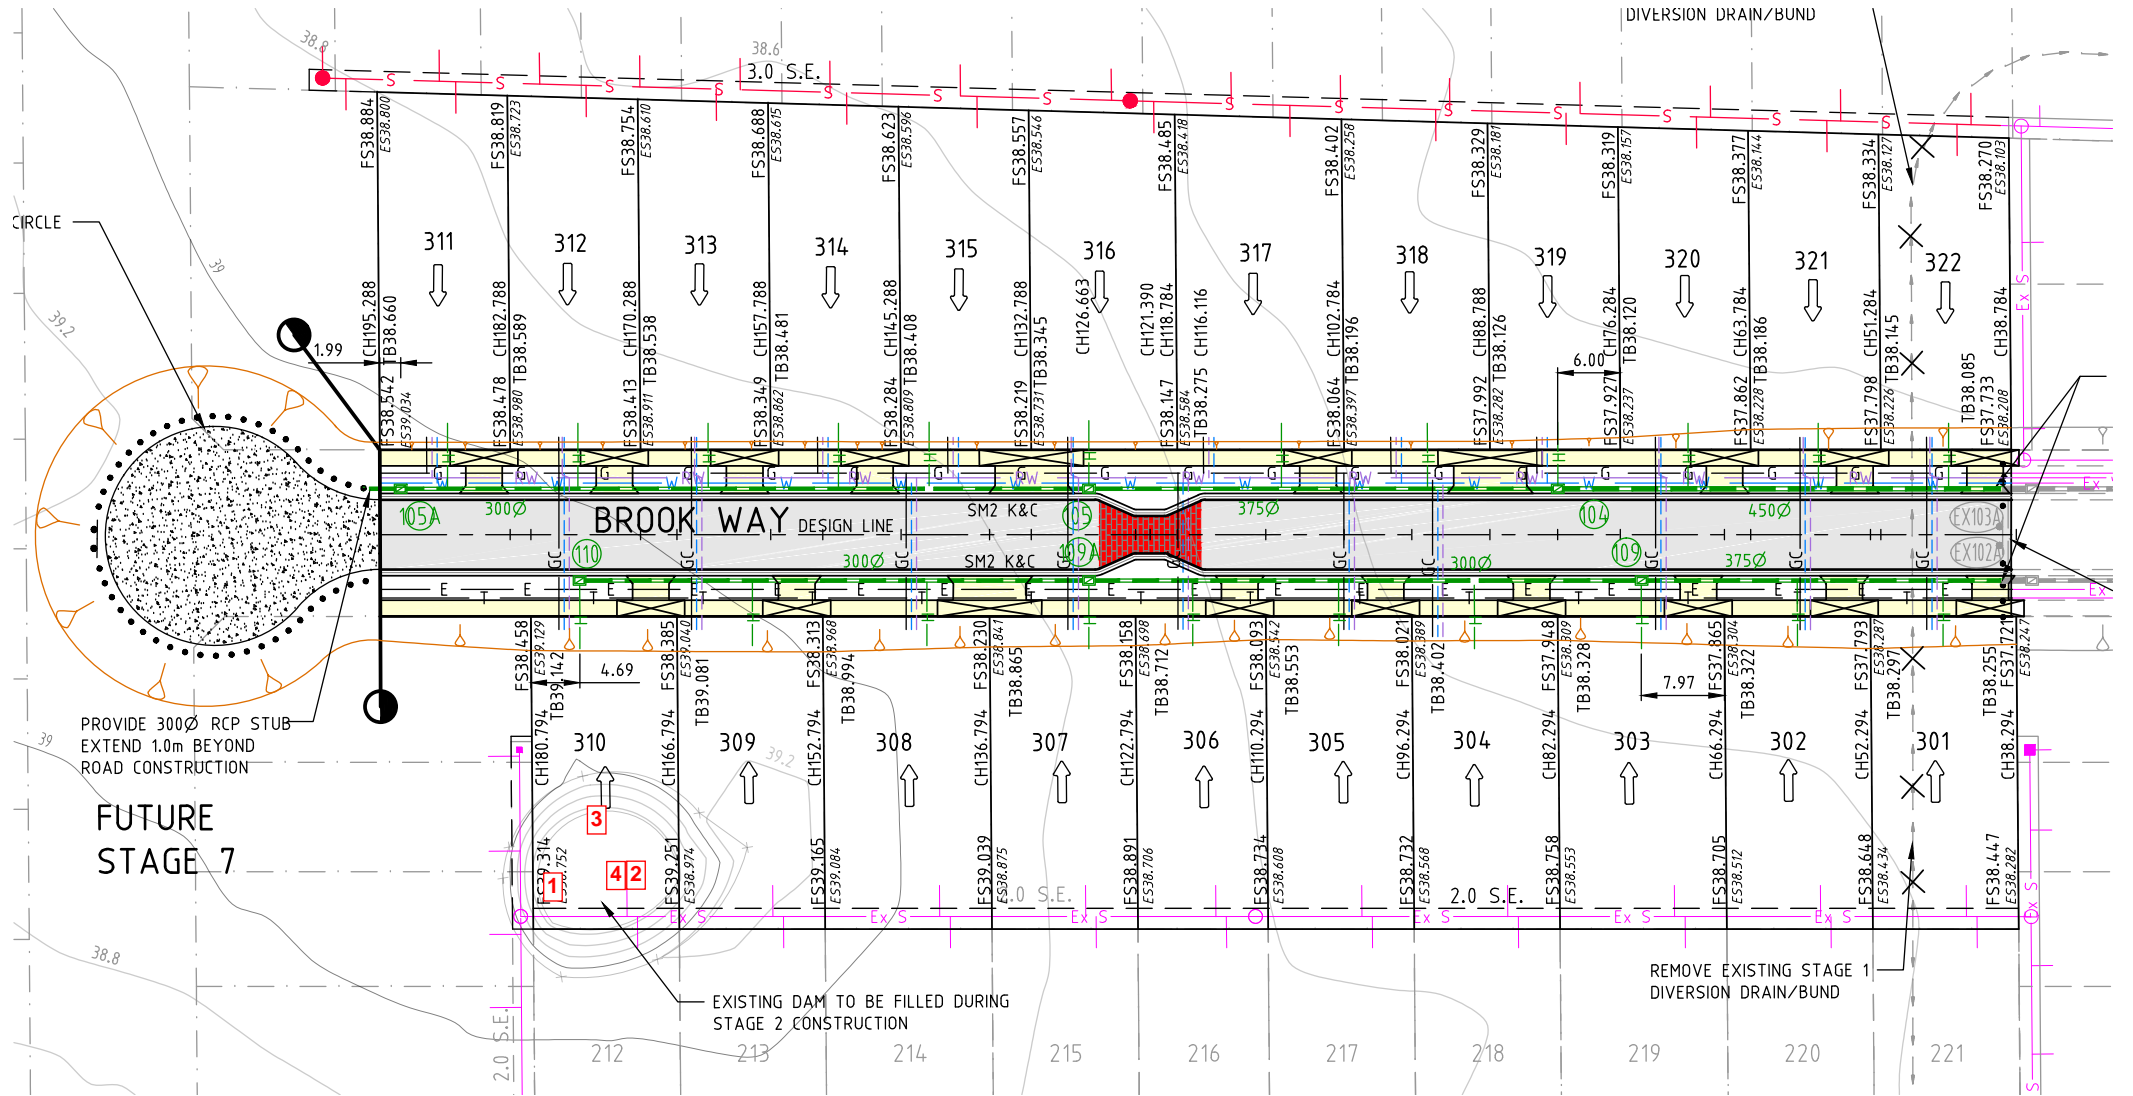
# Test Location Plan

The area on which fill was placed is shown on site plan (Appendix 1) based on drawings prepared by Dalton Consulting Engineers and provided by *Streetworks Pty Ltd*.

It was observed that finished levels were in accordance with levels marked on site by survey. These levels are shown on site plans attached in Appendix 1.

Client : Streetworks Pty Ltd	
Project : Lavender Estate Stage 3, Officer	
Scale	NTS
